15B250003: Tilt Disc Bolt Replacement.

Campaign NO.	15B250003
Campaign Type	Service Measure Check
Info. Version	1.0
Created by	GAIUS RD team
Revised by	GAIUS RD team
Released by	GAIUS After-Sale team
Initial Date	10/Jul/2025
Revised Date	10/Jul/2025
Applicable Model	Rapide XL (RP3)
Affected Units	194
Campaign Description	<p>Vehicles supplied to Australia were found to have four loose bolts in the tilt brake disc area. The instructions are to replace these bolts with part number 9102009-M8: M8 x 1.25 x 20mm flanged hex head bolts, Class 10.9, with zinc flake coating. Please have all affected vehicles returned to service partners for this campaign.</p> <div style="text-align: center;"> <div style="display: inline-block; width: 45%;"> <p>9102004-M8 M8-1.25 x 20mm, Flanged Hex Head Bolt, Class 8.8, Zn Flake - Hex Size: 10mm</p> </div> <div style="display: inline-block; width: 45%;"> <p>9102009-M8 M8-1.25 x 20mm, Flanged Hex Head Bolt, Class 10.9, Zn Flake - Hex Size: 12mm</p> </div> </div>

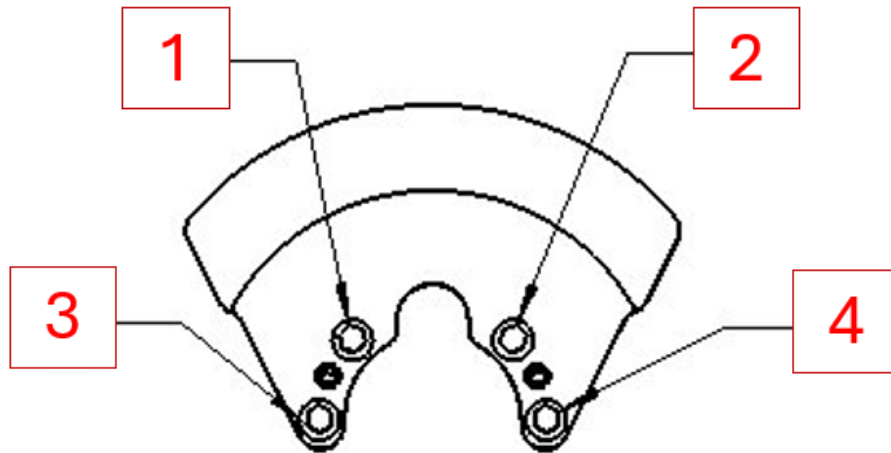
This image is viewed from the front of the vehicle looking toward the rear

9. Replace disc screws in the order shown in the image
