Check brake pads and the caliper from tilt system

Model: Rapid 3 XL (RP3)

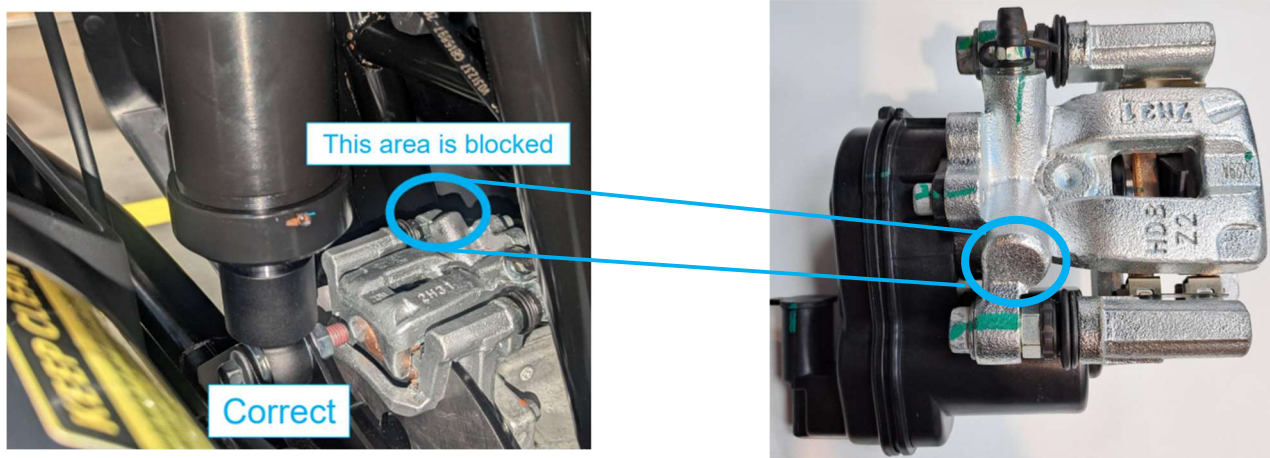
1. Check the caliper from rear-right perspective of the seat apron.

Correct caliper: The blue part should be flat without any pipe hole. Then, jump to Step.2

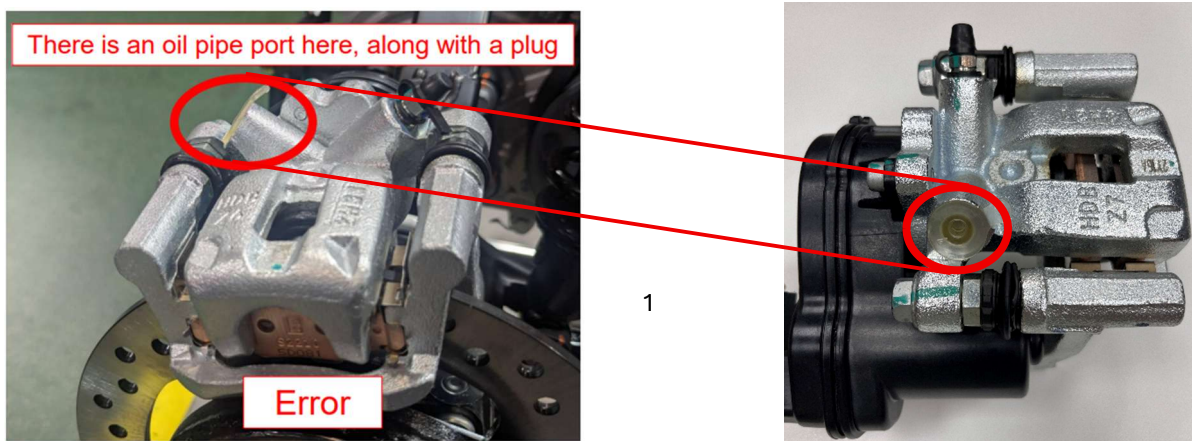
Incorrect caliper: If the vehicle is incorrectly equipped with the wrong caliper, please replace the caliper. (Refer to service manual **15001 Replace the Tilt Brake Caliper**)

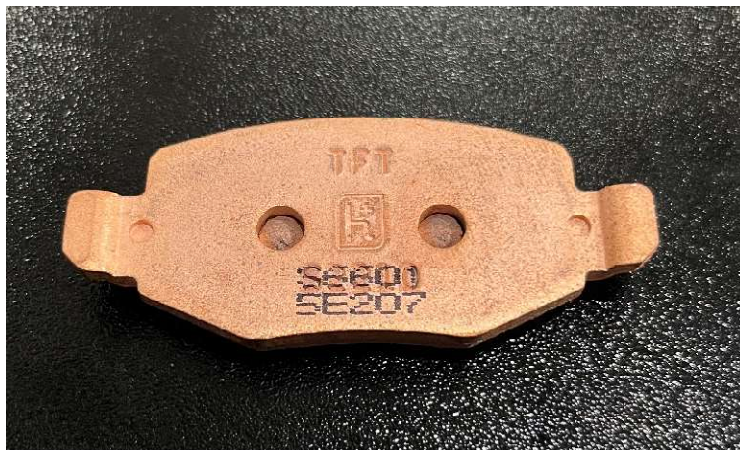
Example:

2. Check the production number on brake pads.

Correct production number: S6601

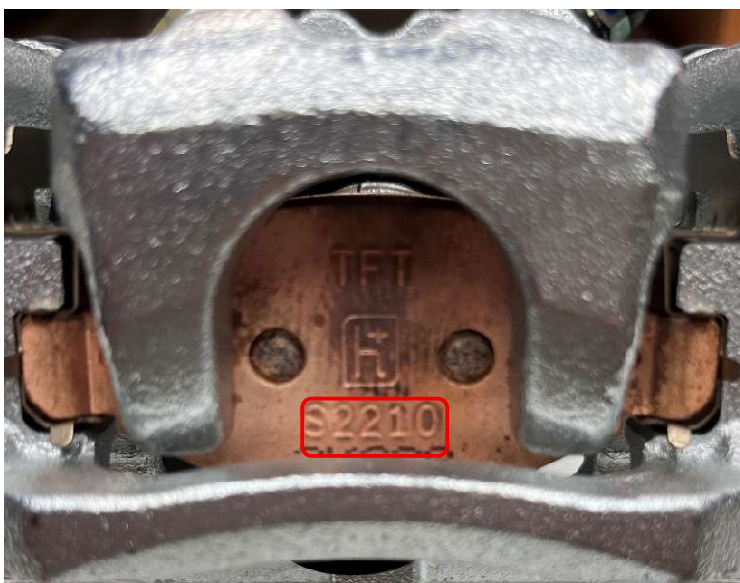
Example:

Incorrect production number: S2210 or other production number.

Please replace a pair of brake pads.(Refer to service manual
15002 Tilt Brake Pads)
