15B250004: Tilt Disc Split Pins Check/ Replacement and Disc Bolts Replacement.

Campaign NO.	15B250004
Campaign Type	Service Measure Check
Info. Version	1.0
Created by	GAIUS RD team
Revised by	GAIUS RD team
Released by	GAIUS After-Sale team
Initial Date	14/Jul/2025
Revised Date	14/Jul/2025
Applicable Model	Rapide XL (RP3)
Affected Units	500
Campaign Description	<p>1. Vehicles supplied to Australia were found to have four loose bolts in the tilt brake disc area. The instructions are to replace these bolts with part number 9102009-M8: M8 x 1.25 x 20mm flanged hex head bolts, Class 10.9, with zinc flake coating. Please have all affected vehicles returned to service partners for this campaign.</p> <div data-bbox="481 1167 1096 1538" data-label="Image"> <p>9102004-M8 M8-1.25 x 20mm, Flanged Hex Head Bolt, Class 8.8, Zn Flake - Hex Size: 10mm</p> <p>9102009-M8 M8-1.25 x 20mm, Flanged Hex Head Bolt, Class 10.9, Zn Flake - Hex Size: 12mm</p> </div> <p>2. The tilt brake disc bolts will become loose and resulting split pins come out. If any split pin is found (even only with one side) dislodged on vehicle, both sides of slip pins shall be replaced with new ones as per the instructions in the

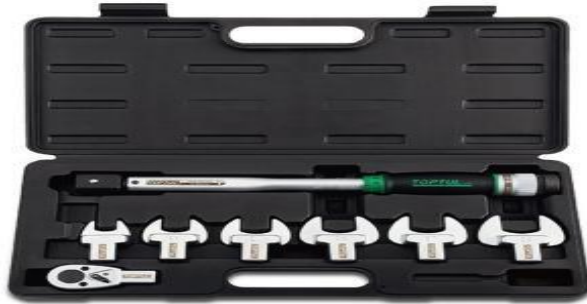
1. Special torque wrench tool

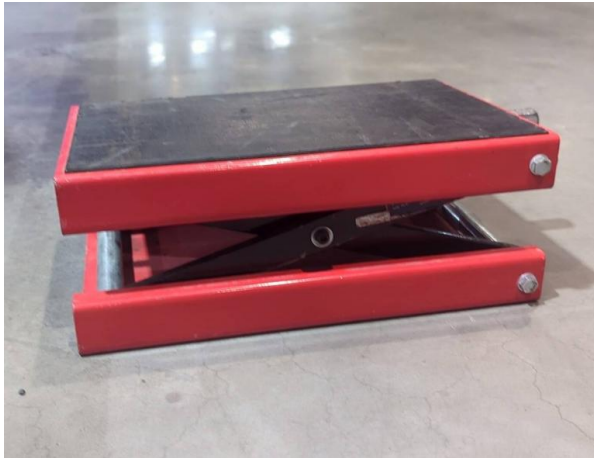
4. Scissors jack

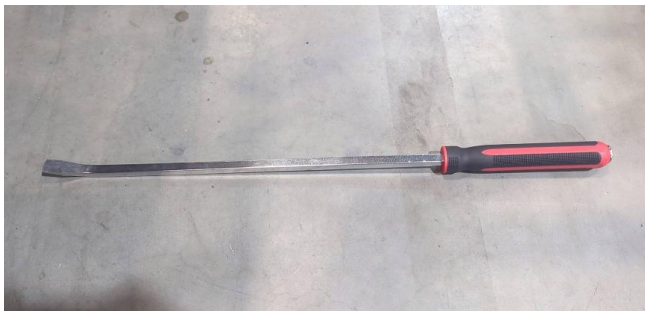
5. Large pry bar

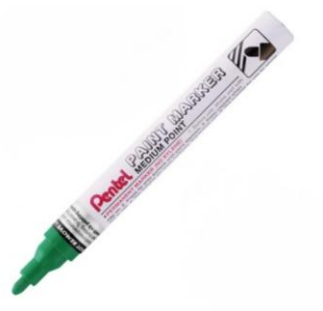
6. Green indelible paint pen

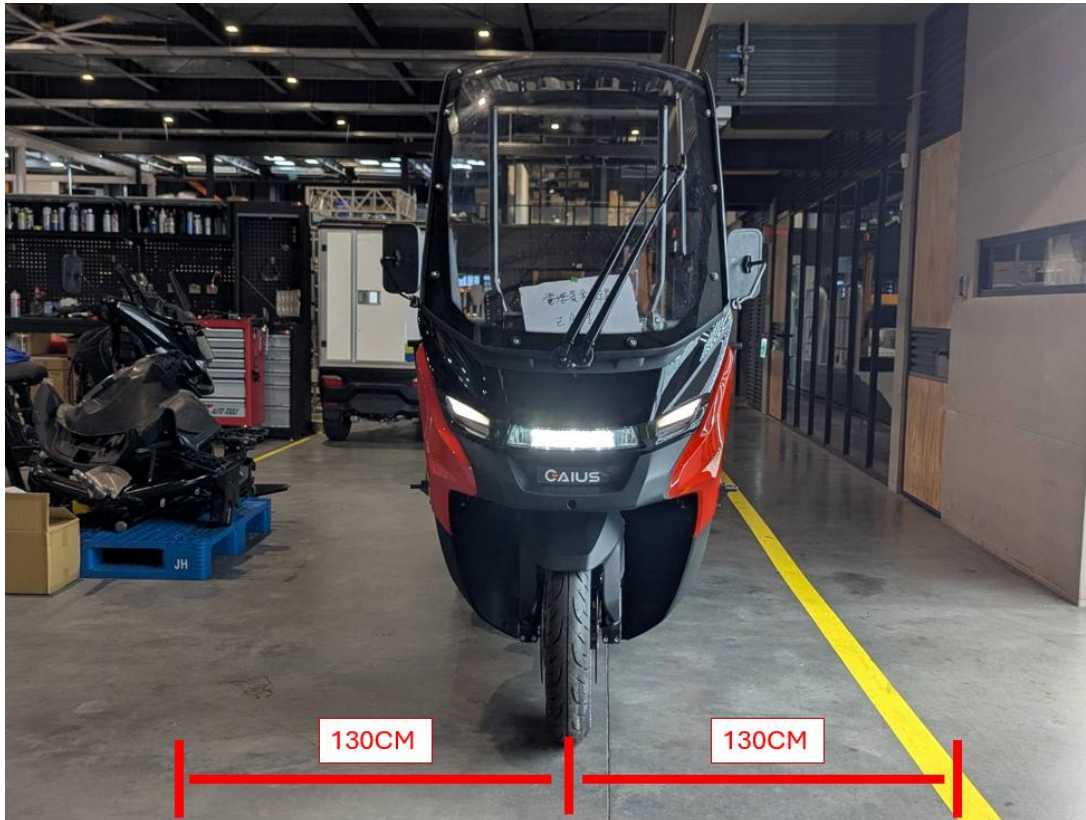
1. Park the vehicle in a level maintenance area, ensuring a clearance of at least 130 cm on both left and right sides to allow vehicle tilting.

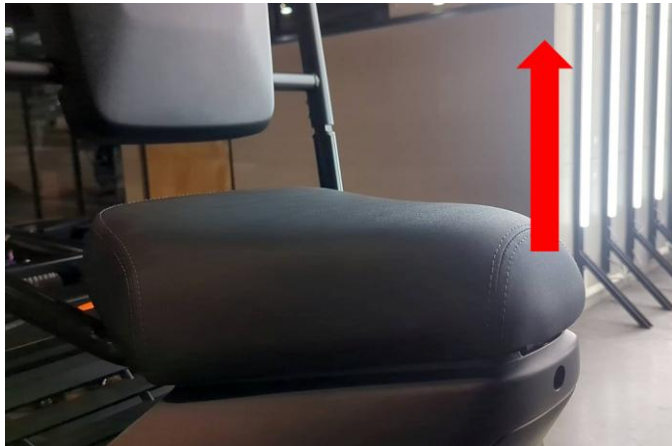
3. Lift the front end of the seat upward.

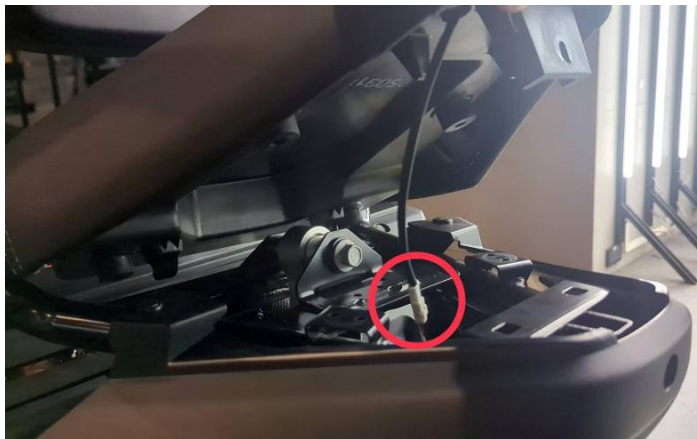
4. Disconnect the seat sensor connector.

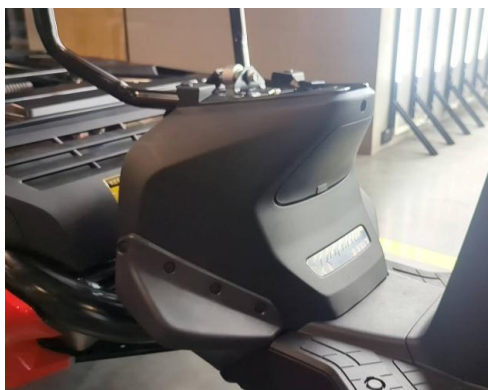
5. Remove the seat apron.

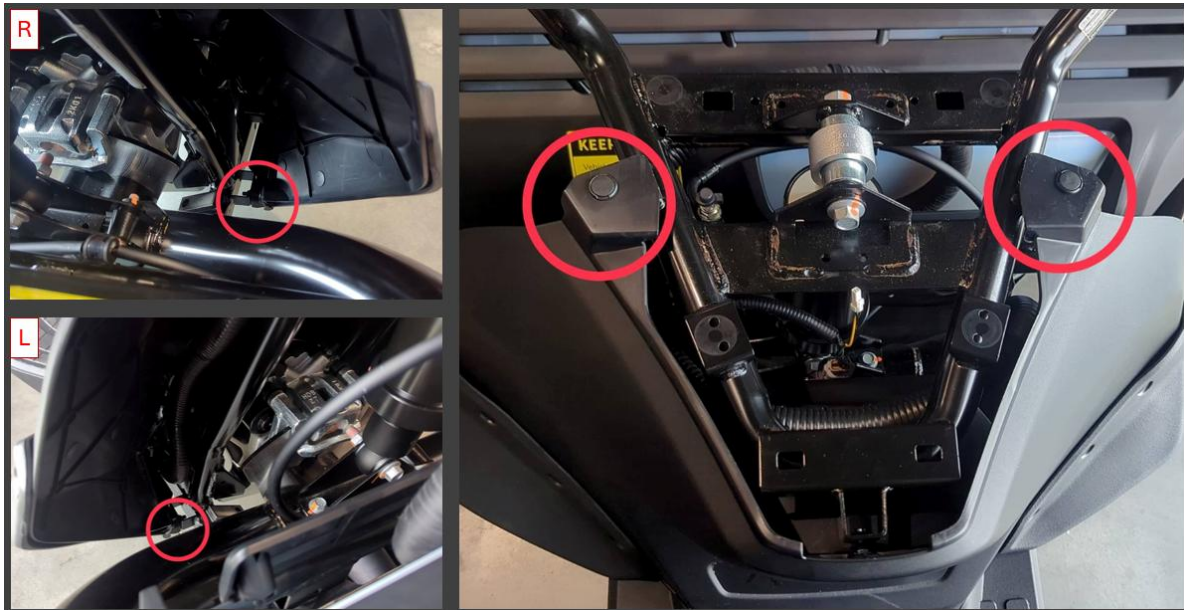
6. There are two mounting clips on the top, and one clip on each lower left and right side.

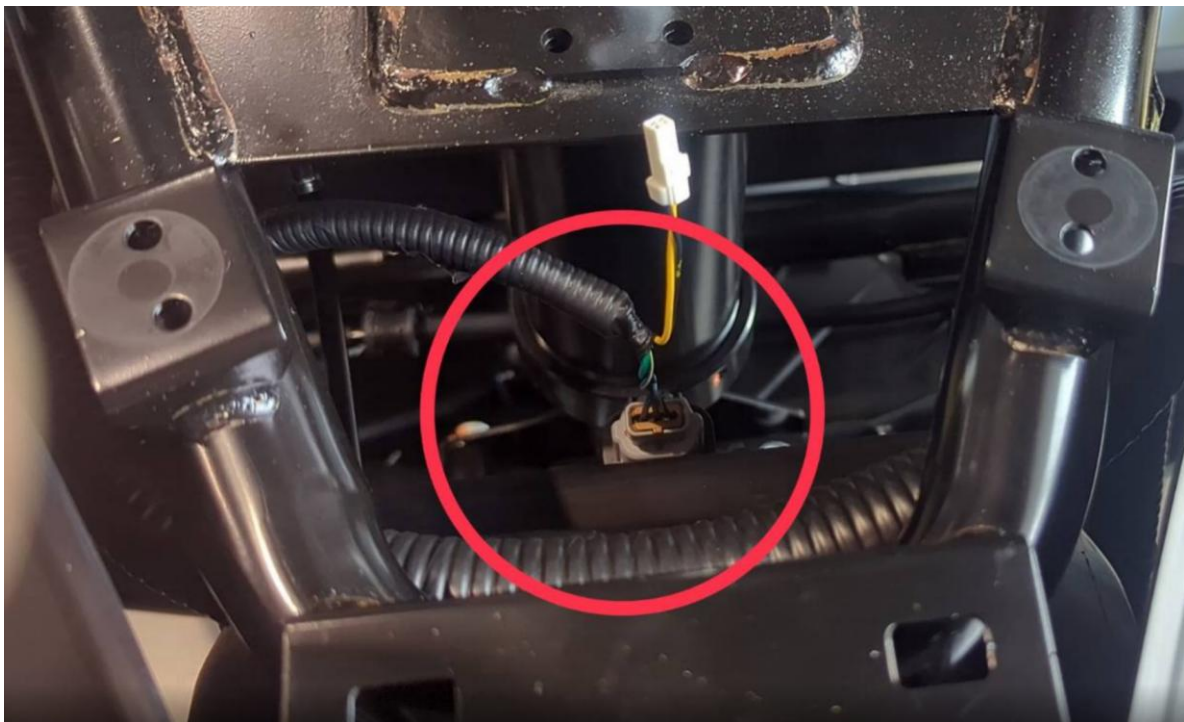
7. Disconnect the rollover sensor connector.

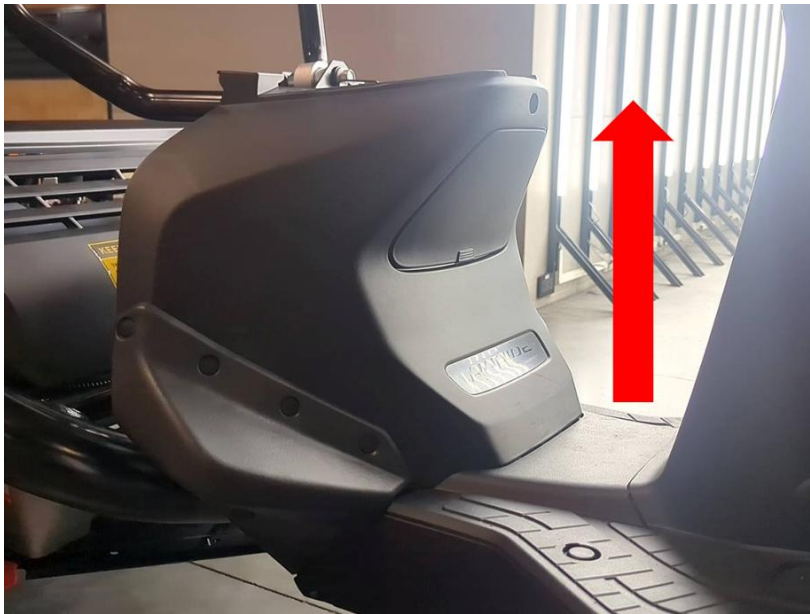
8. Pull the seat apron upwards.

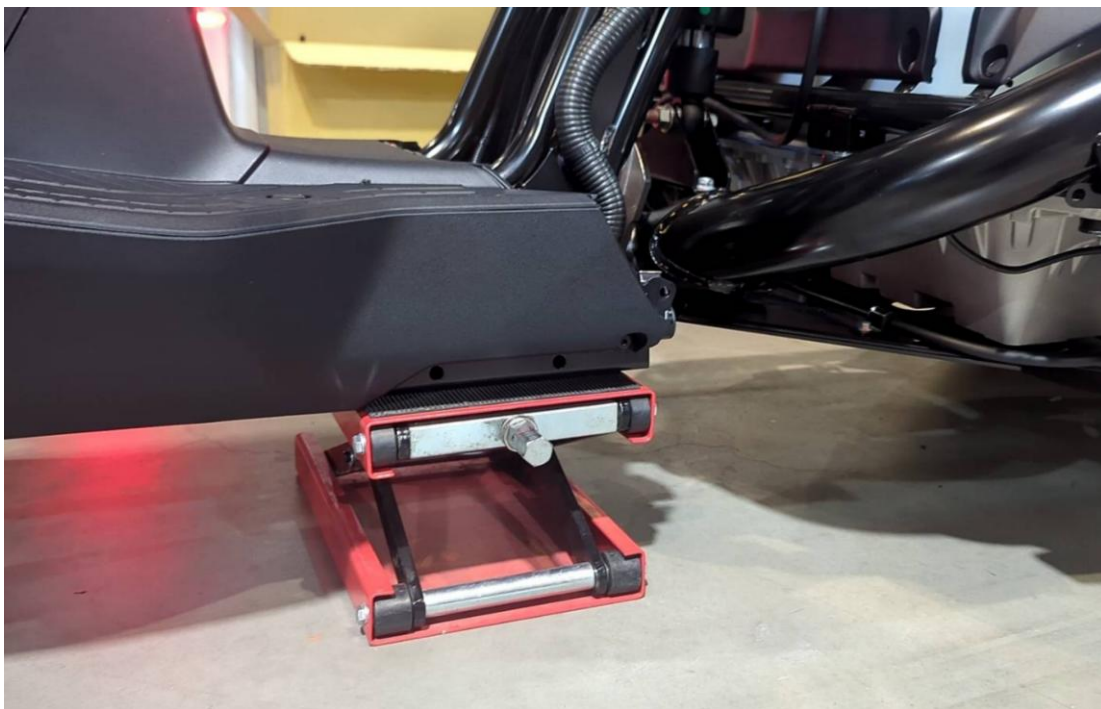
9. Place the jack under footrest to support the vehicle. This step is critical because the next step requires unlocking the tilt lock. **If not properly supported, the front of the vehicle will immediately tip over.**

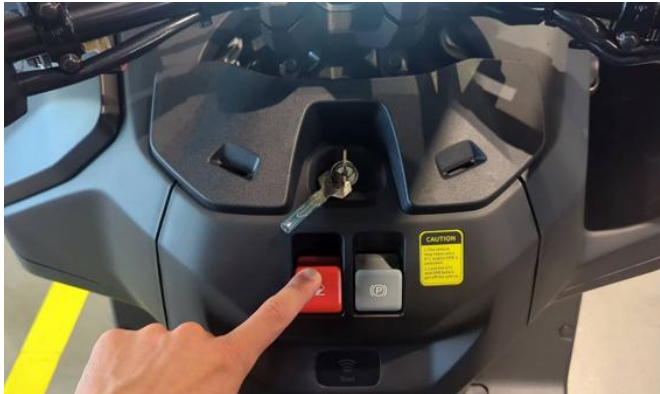
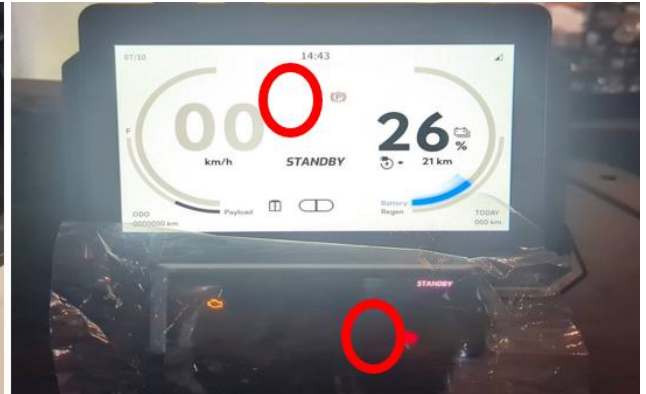
10. Set the vehicle's ETL (Electronic Tilt Lock) to Maintenance Mode.
11. Release ETL (Electronic Tilt Lock) so that lock icons on both DASH and IDU disappear.
12. Press and hold the ETL button for 10 seconds. ETL icon on the DASH will begin to flash. Once it starts flashing, press the button again to enter Maintenance Mode.

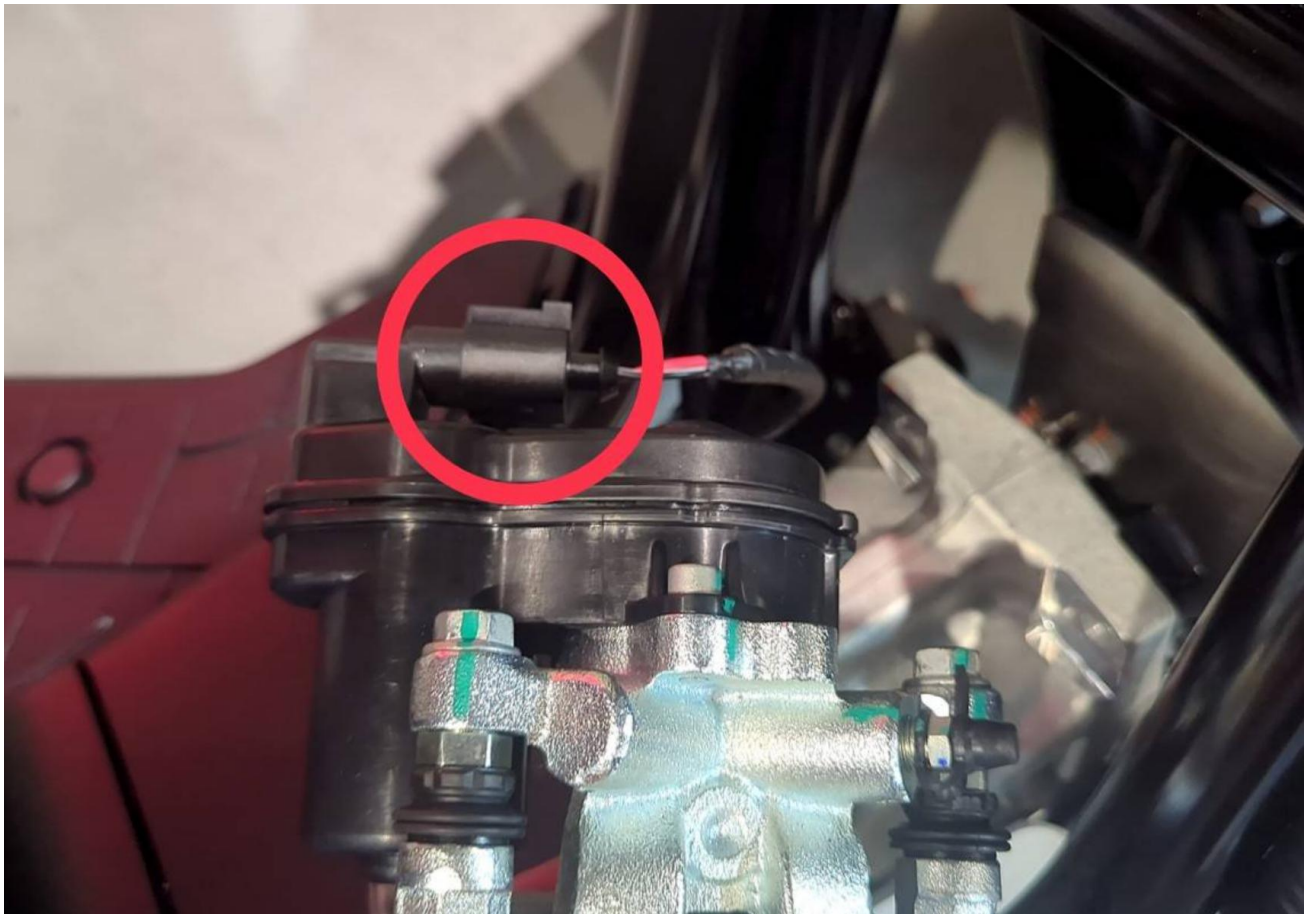
14. Disconnect tilt brake caliper motor connector.

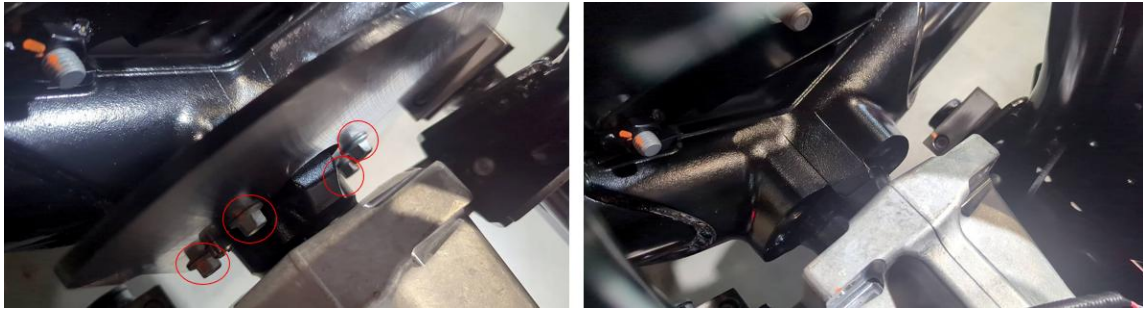
16. Remove tilt disc mounting bolts x4 and remove disc.

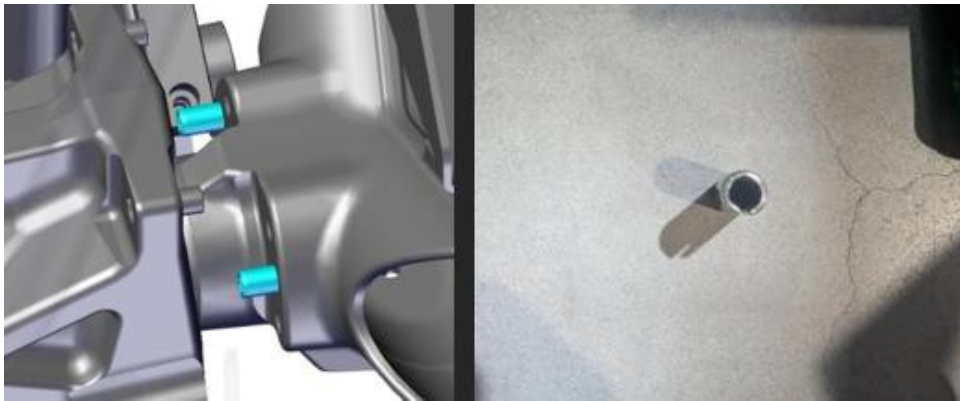
18. Insert/set new split pins into rear chassis. Pins should be installed with the open groove down to minimize water accumulation.

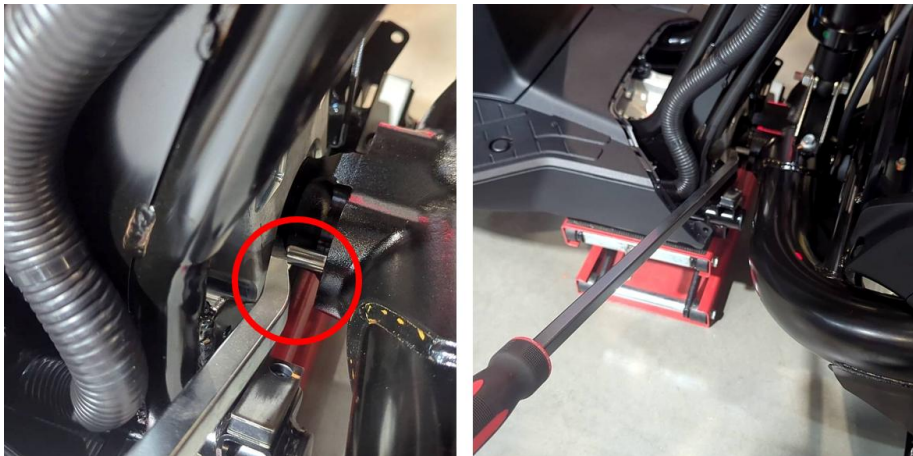
19. Use a large pry bar to press the retaining pin in by applying leverage.

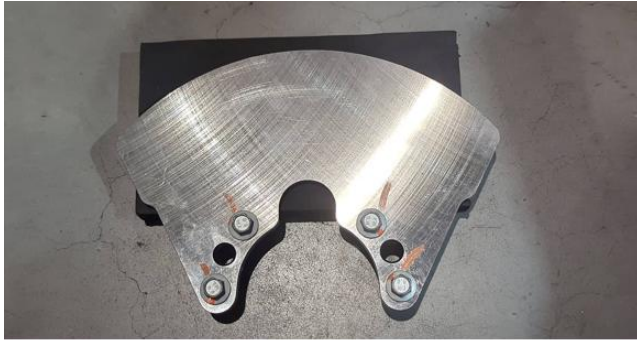
20. First, place the old screws onto the disc, then install the disc onto the rear chassis. Evenly tighten screws to secure disc, and push disc into split pins.

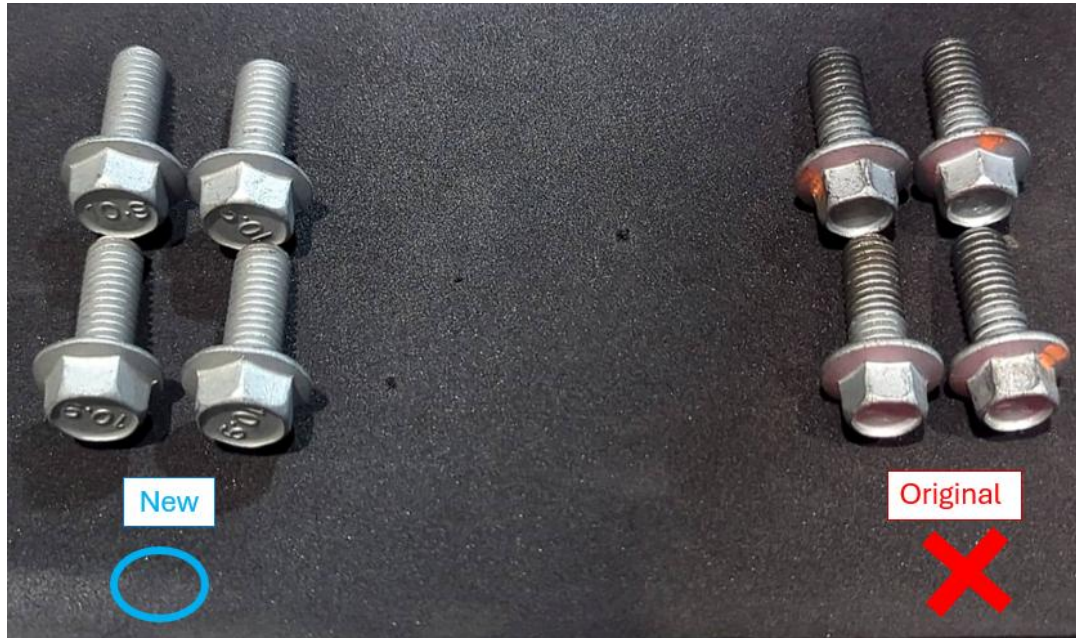
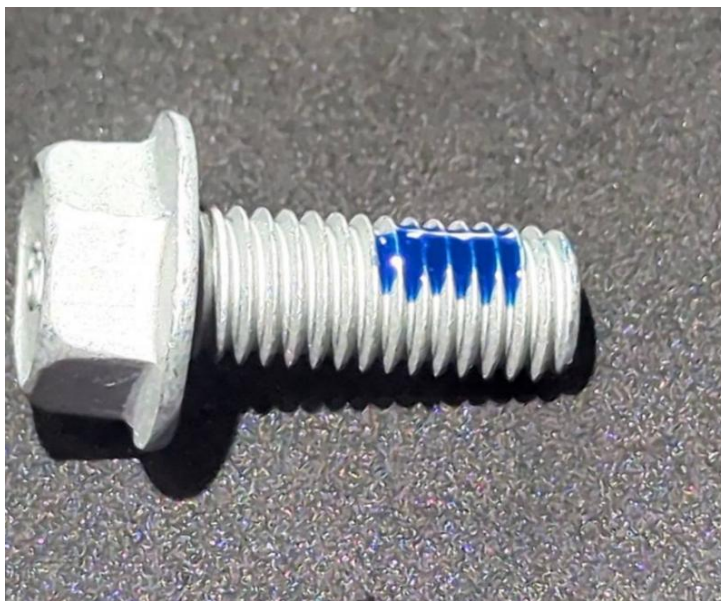
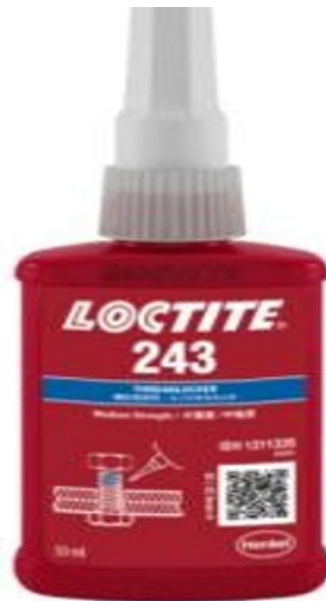
22. Replace with the correct screws. Apply thread locker (Loctite 243 or equivalent) to the threads of the new screw, leaving the first two threads uncoated. Begin applying the thread locker from the 5th or 6th thread onward.

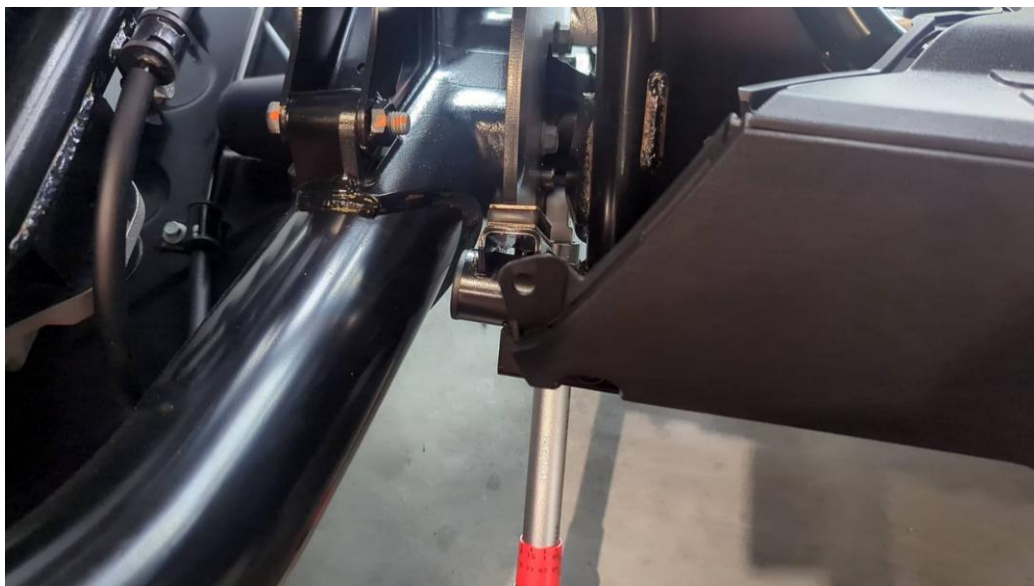
23. Raise the jack to the height of 27 cm from the floor that permits proper operation of torque wrench. Hand-tighten screws until seated, then use special tool to torque it to 30 N-m.

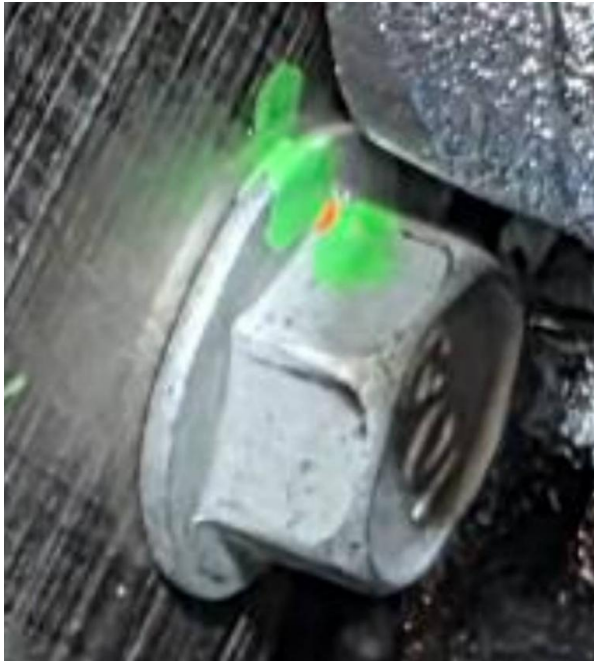
24. After tightening screws, mark it with a green paint marker.

36. After tightening screw, mark it with a green paint marker. (Refer to the image in Step 32)

42. After tightening screw, mark it with a green paint marker. (Refer to the image in Step 32)

48. After tightening screw, mark it with a green paint marker. (Refer to the image in Step 32)
49. After replacing all four screws, apply a green mark on the back of disc to indicate that screws have been properly replaced on this vehicle.

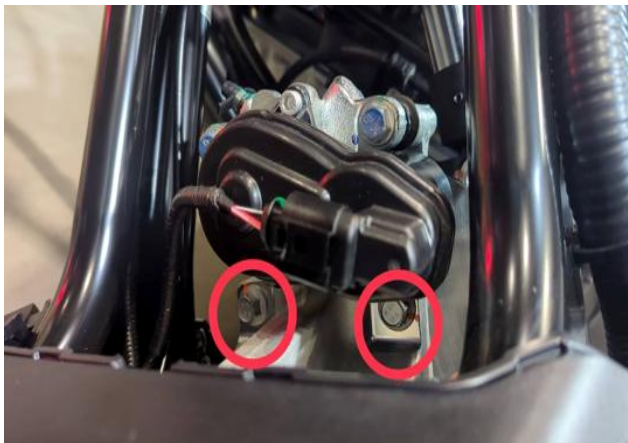
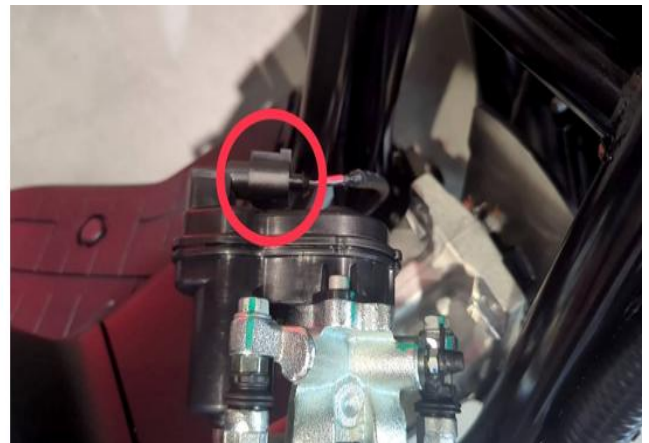
25. Install tilt brake caliper and torque mounting bolts to 65 N-m. Reconnect tilt brake motor connector.

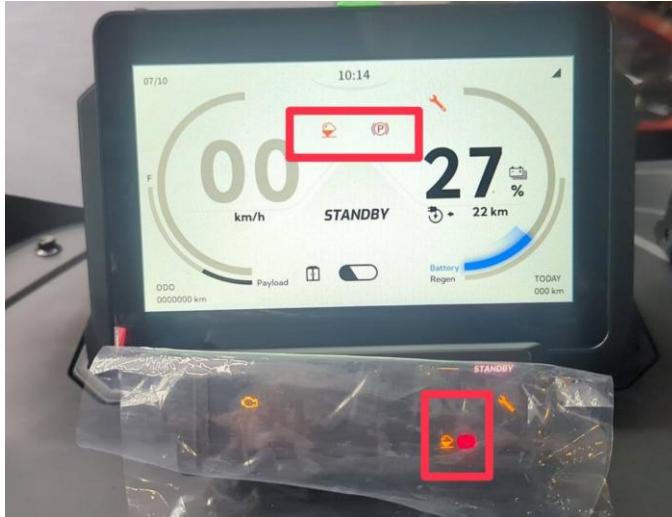
26. Please pull up the ETL and make sure that the EPB and ETL are fully locked. The lock icon will be displayed on the instrument panel and IDU. After confirming that the lock is locked, turn off the vehicle power and remove the scissor jack.

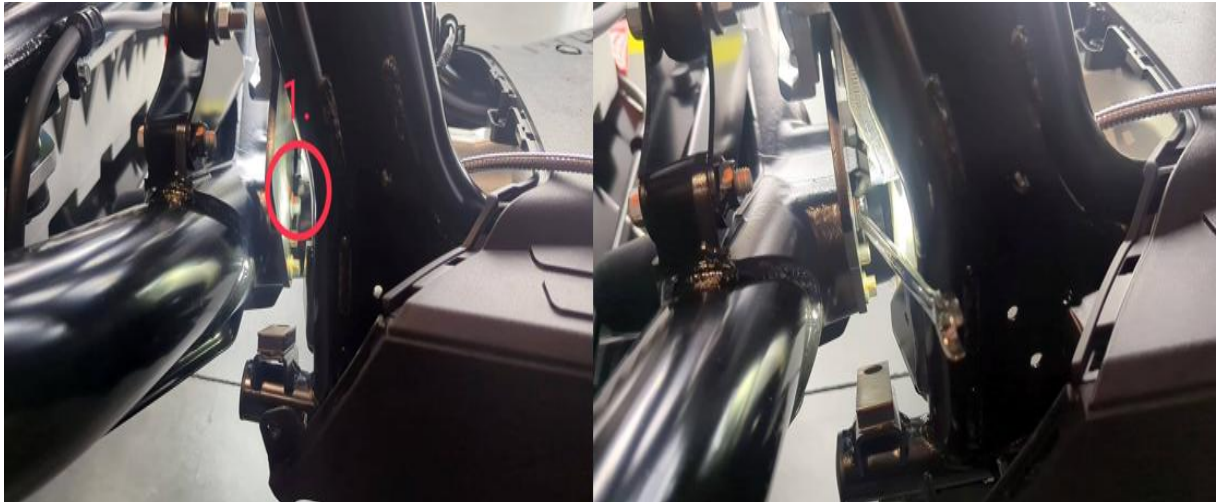
28. Use a plum open-end wrench to loosen fixing the screw on upper right side of disc.

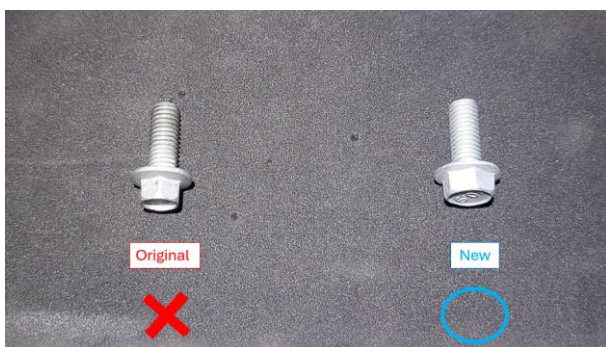
29. Replace with correct screw.

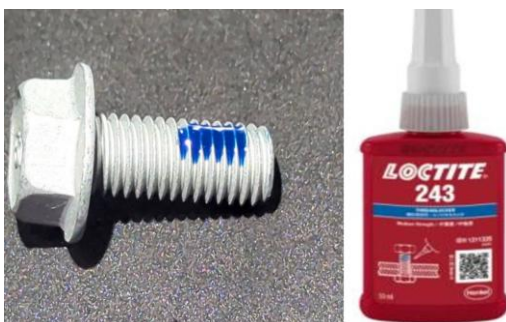
30. Apply thread locker (Loctite 243 or equivalent) to threads of the new screw. Leave the first two threads uncoated and apply thread locker starting from 5th to 6th thread onward.

34. Replace with the correct screw. Apply thread locker (Loctite 243 or equivalent) to threads of the new screw, leaving first two threads uncoated. Begin applying thread locker from 5th or 6th thread onward. (Refer to the image in Step 30.)

40. Replace with correct screw. Apply thread locker (Loctite 243 or equivalent) to threads of the new screw, leaving first two threads uncoated. Begin applying thread locker from 5th or 6th thread onward. (Refer to the image in Step 30.)

46. Replace with the correct screw. Apply thread locker (Loctite 243 or equivalent) to threads of the new screw, leaving first two threads uncoated. Begin applying thread locker from 5th or 6th thread onward. (Refer to the image in Step 30.)
47. Hand-tighten screw until seated, then use special tool to torque it to 30 N-m.

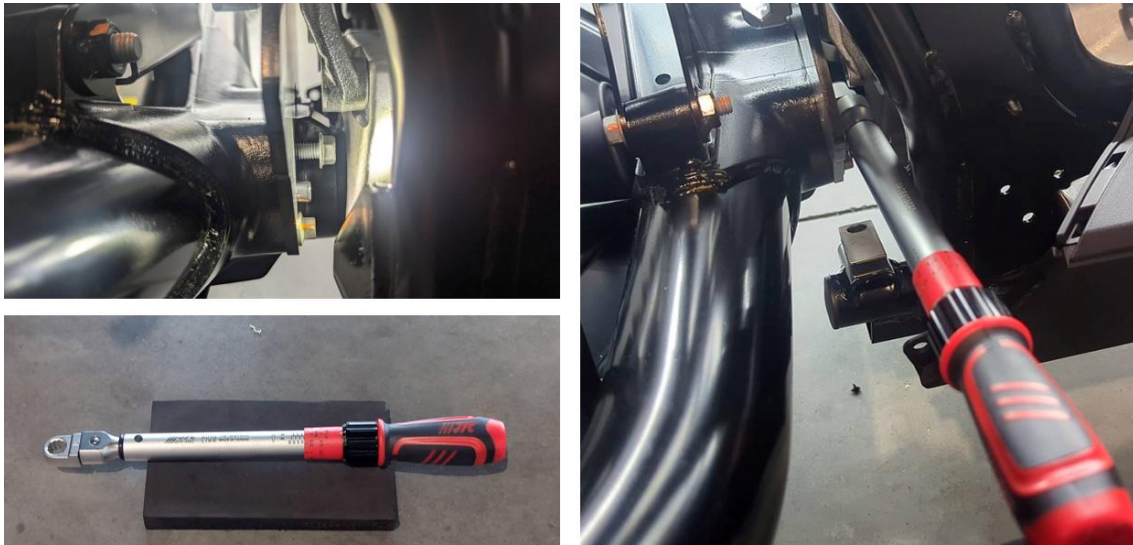
31. Hand-tighten screw until seated, then use special tool to torque it to 30 N-m.

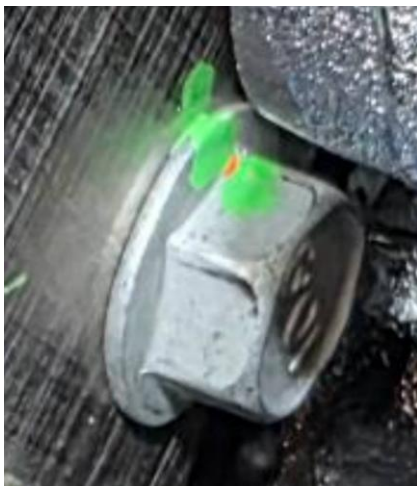
32. After tightening screw, mark it with a green paint marker.

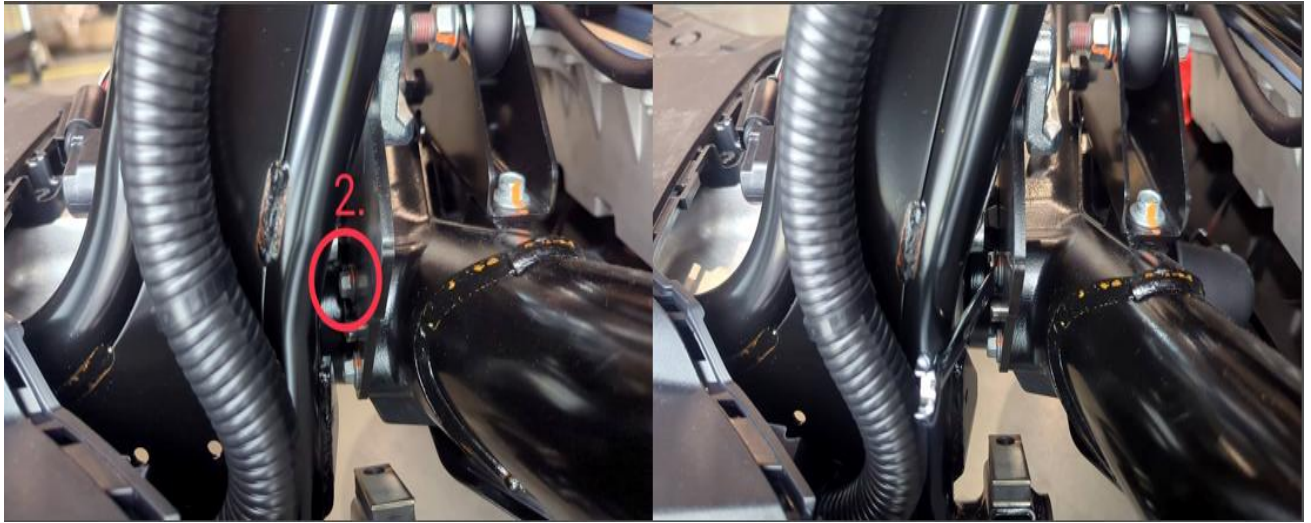
33. Use a plum open-end wrench to loosen fixing screw on the upper left side of disc.

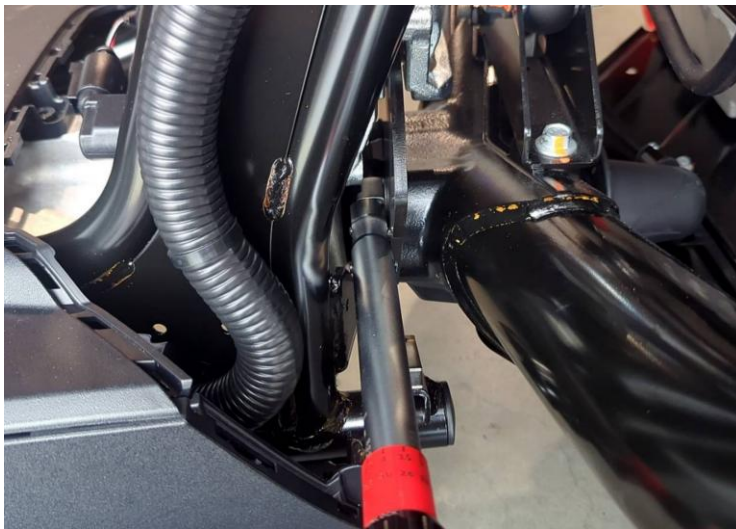
35. Hand-tighten screw until seated, then use special tool to torque it to 30 N-m.

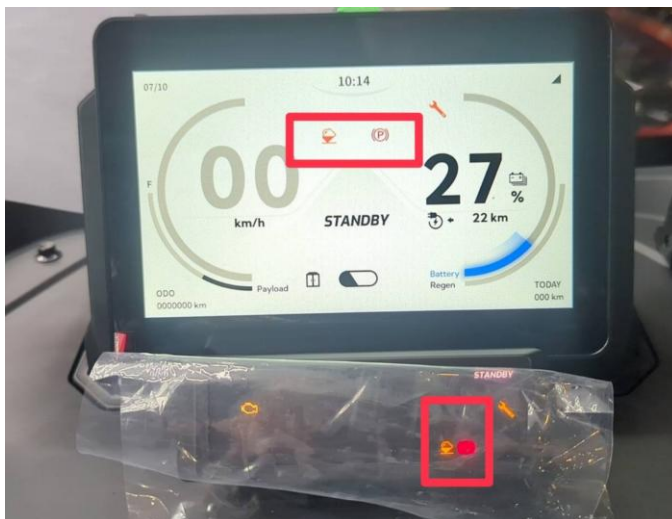
38. Please ensure that EPB and ETL are fully locked after tilting. Lock icons will be displayed on both Dash and IDU. Power off vehicle only after confirming locks are engaged before proceeding with any work.

44. Please ensure that EPB and ETL are fully locked after tilting. Lock icons will be displayed on both Dash and IDU. Power off vehicle only after confirming locks are engaged before proceeding with any work. (Refer to the image in Step 38)

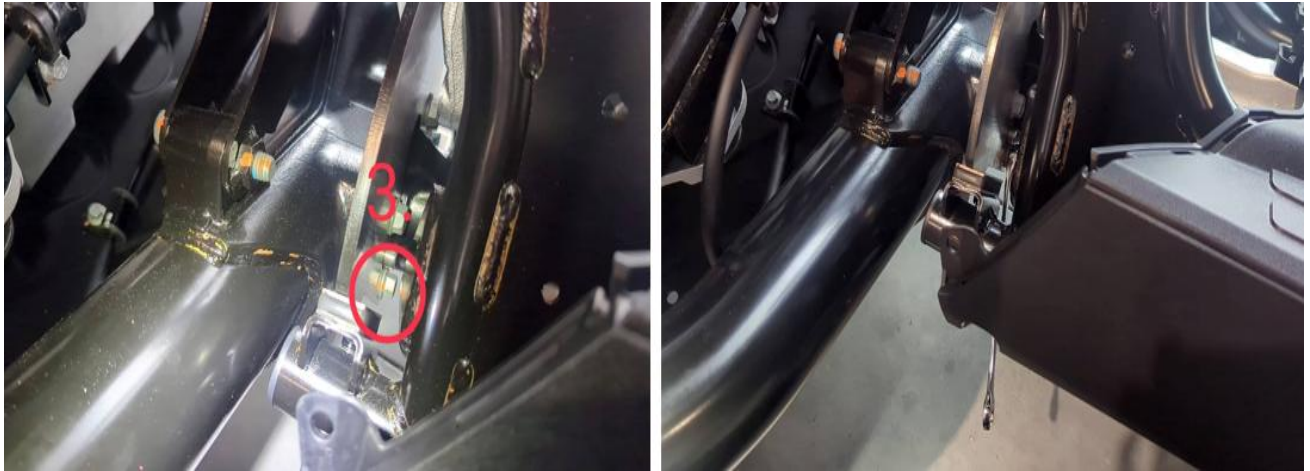
39. Use a plum open-end wrench to loosen fixing screw on the down right side of disc.

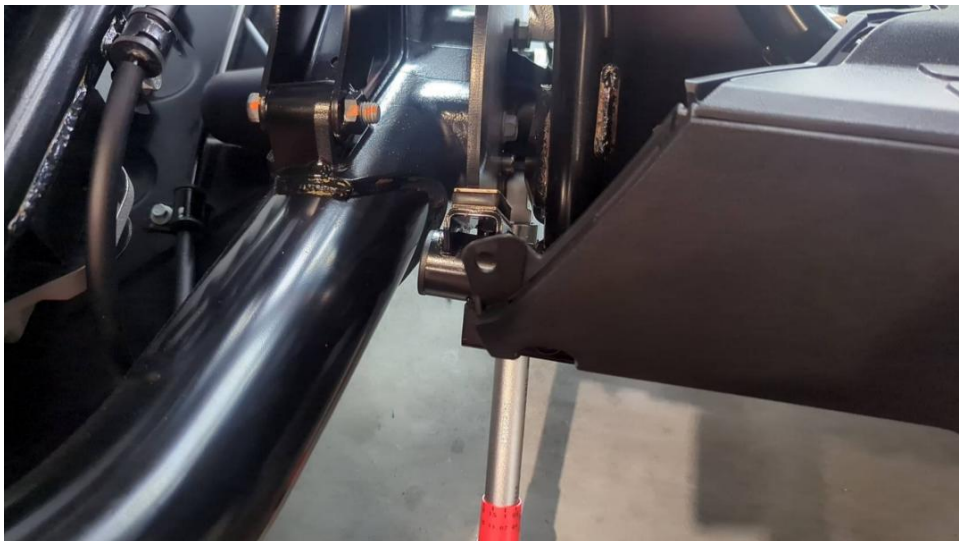
41. Hand-tighten screw until seated, then use special tool to torque it to 30 N-m.

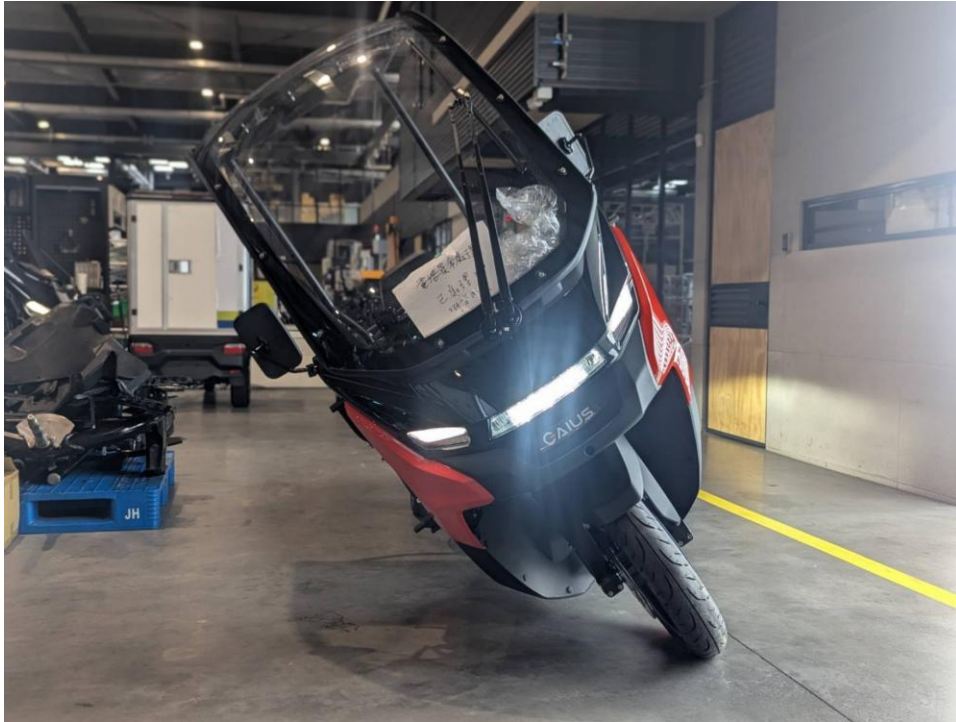
43. Tilt vehicle fully to the right.

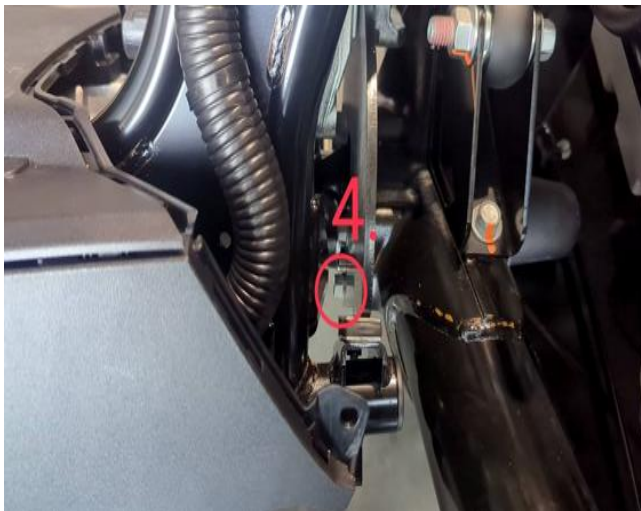
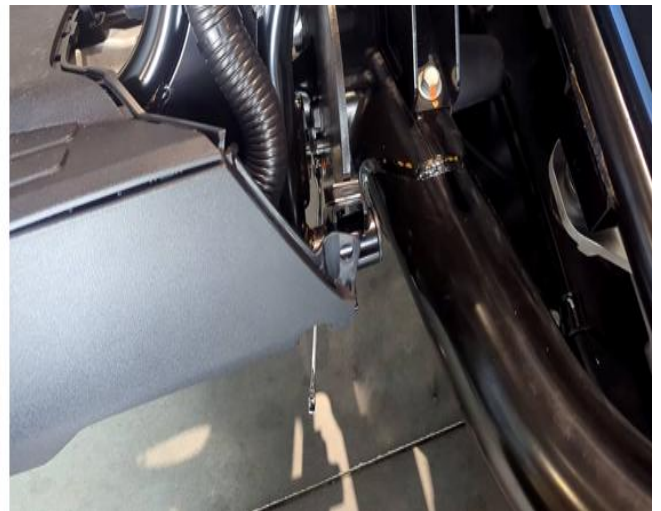
45. Use a plum open-end wrench to loosen fixing screw on the down left side of Disc.

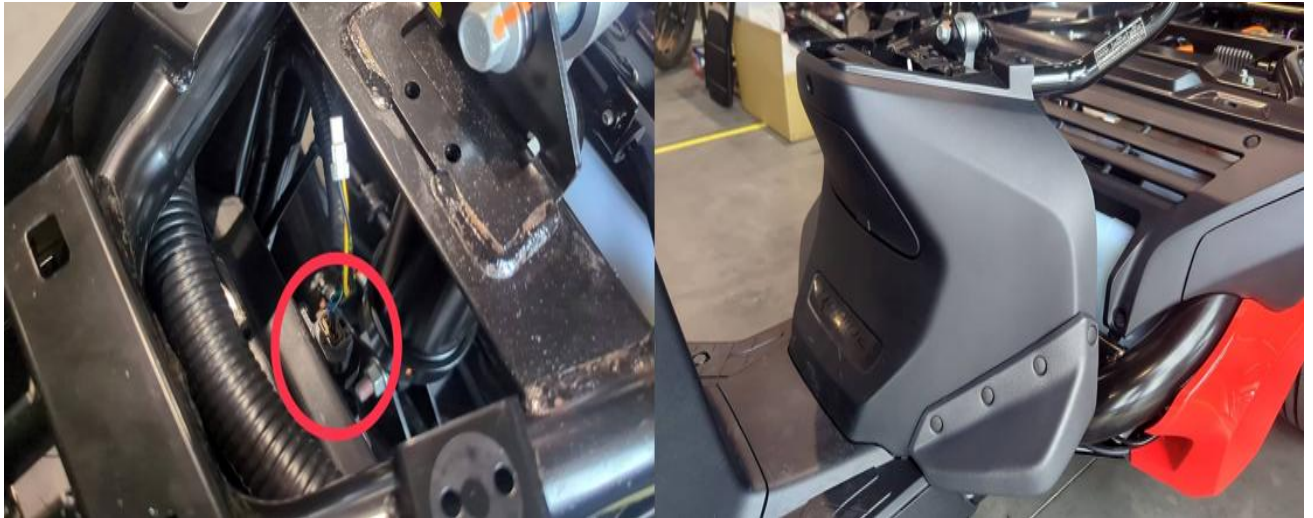
50. Reinstall seat apron and connect rollover sensor connector.

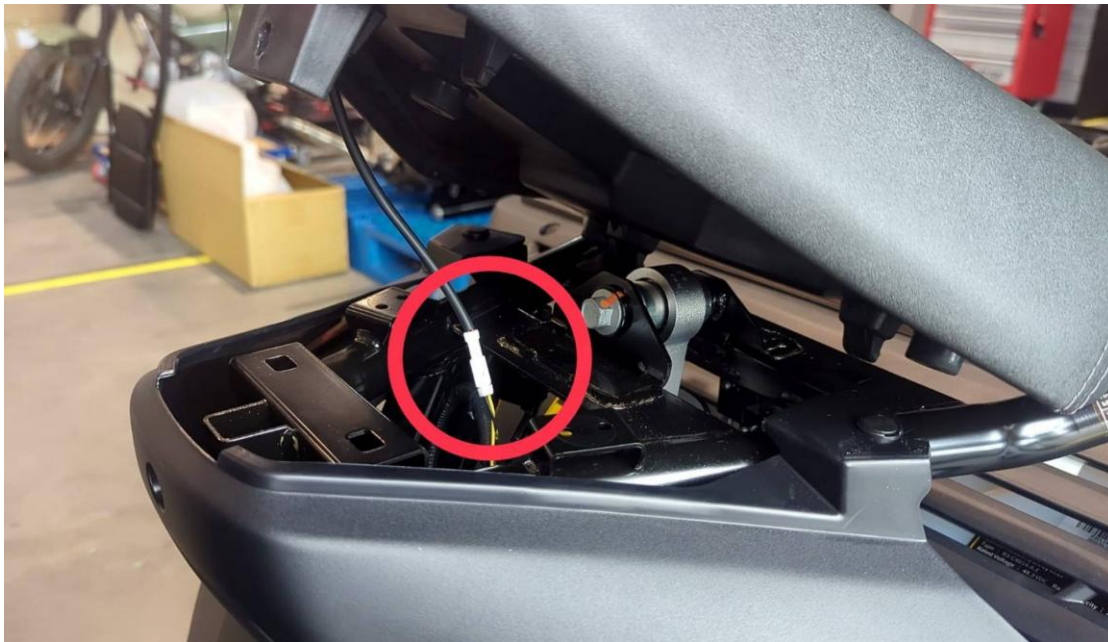
51. Before reinstalling the seat, ensure seat sensor connector is properly connected.

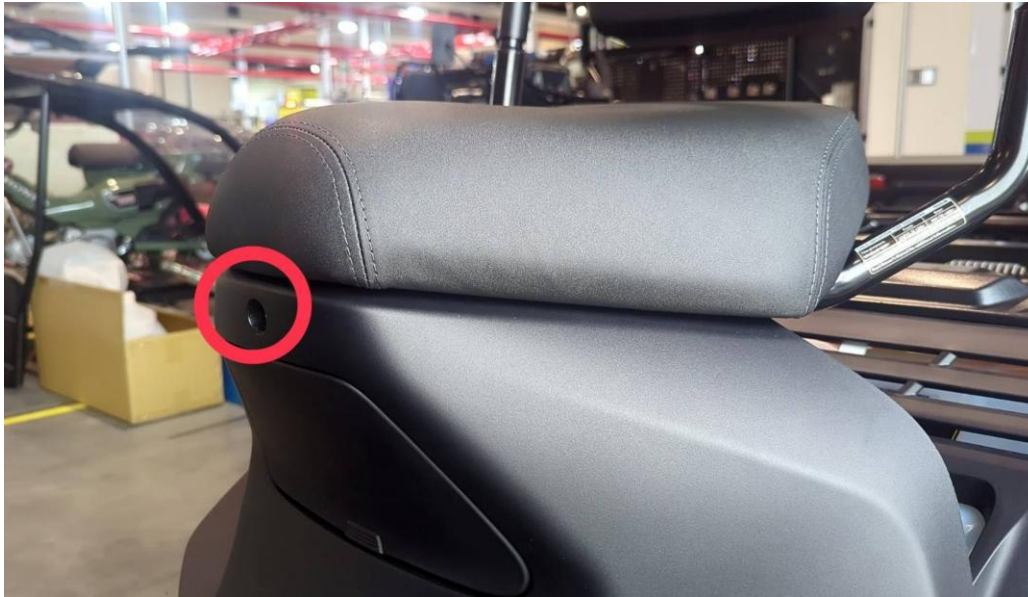
52. Tighten seat mounting bolts.
