12A250017: OPDS Inspection Guide

Campaign NO.	12A250017
Campaign Type	Pre-Delivery Check
Info. Version	1.0
Created by	GAIUS EE team
Revised by	GAIUS EE team
Released by	GAIUS After-Sale team
Initial Date	2025/10/1
Revised Date	2025/10/1
Applicable Model	Rapid XL (RP3)
Affected Units	All vehicles in ALSR.
Campaign	Seat sensor inspection
Description	
Version	
Difference

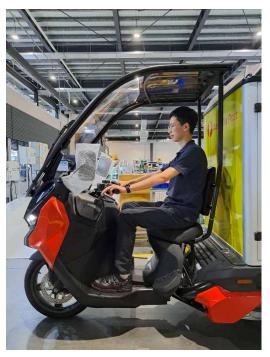
- The OPDS of the Rapid 3 seat is designed based on a human model of 1.55 m / 40 kg or above. Under a normal seating posture, it should be able to maintain good sensing performance.
- 2. The figure below shows individuals of different body types seated, all tested under a normal riding posture.

A. 1.84m/62Kg

B. 1.82m/76Kg

3. With four individuals of different body types seated, the OPDS was able to sense properly. However, under a "normal seating posture," taller and slimmer individuals, due to the support of the seatback, may not naturally sit all the way to the rear end of the seat. The rear-most area of about 4 cm on the seat is also a sensing blind spot.

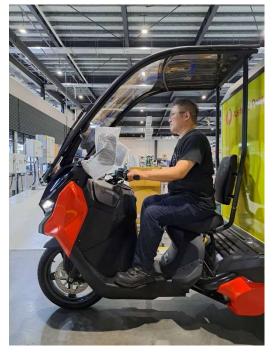
C. 1.68m/86Kg

D. 1.54m/48Kg

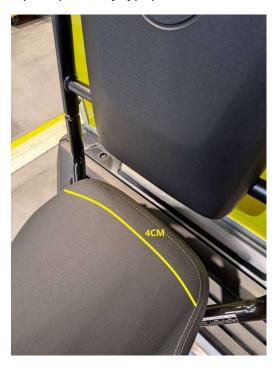
- 4. If one deliberately sits at the very rear end of the seat, it will affect riding comfort, increase the feeling of back impact caused by vibration, and also affect the sensing performance of the OPDS.
- 5. It is recommended that OPDS function testing be carried out **in a normal seating posture, with the occupant naturally leaning against the seatback**. Avoid deliberately sitting within the rear 4 cm of the seat (though this may be unavoidable for individuals with a plumper body type).
